WATERVILLE SEWER PRIORITY REPLACEMENTS

TOWN OF
WATERVILLE, WASHINGTON
SEWER VIDEO INSPECTION PRIORITIES

FIGURE
1

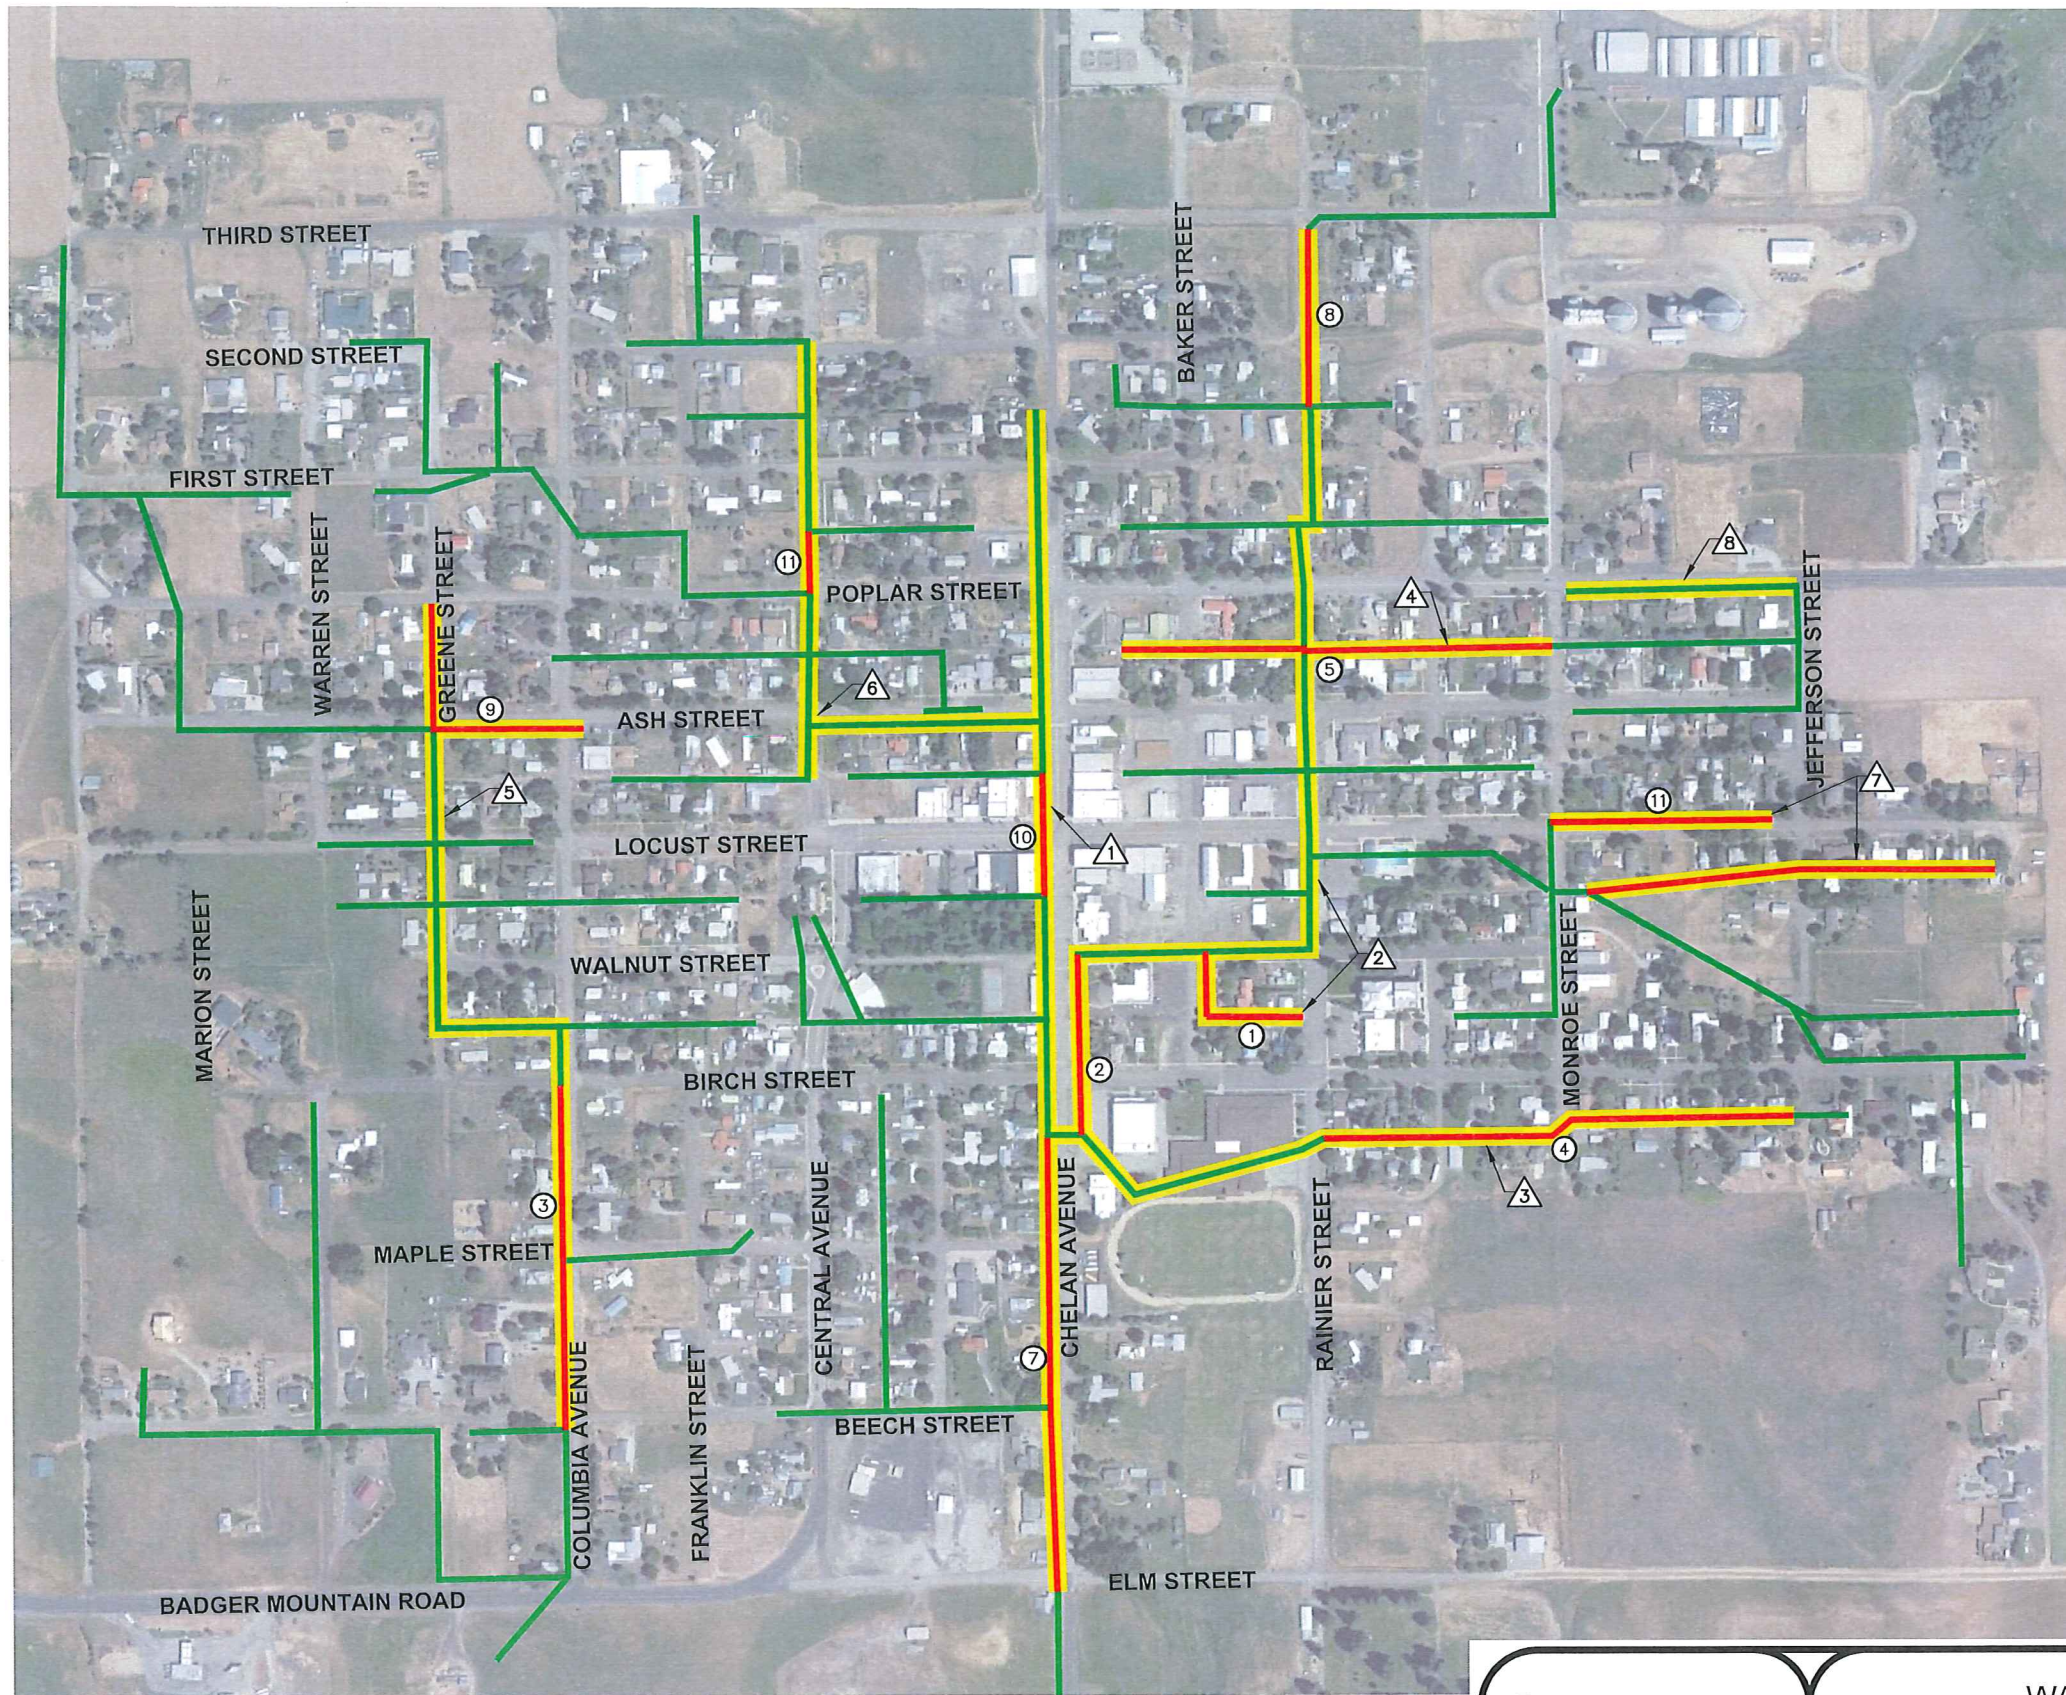
- ▲ VIDEO INSPECTION AREA PRIORITY NUMBER
- ① 6" VITRIFIED CLAY, PROBLEM IS ROOTS IN PIPE. PIPE IS ONLY 2" DEEP AT RAINIER STREET WITH A GRADE CHANGE OCCURRING IN THE ALLEY BEFORE IT REACHES BAKER STREET. NO MANHOLE (MH) AT GRADE CHANGE. OPTION IS TO EXPOSE THE LINE IN THE ALLEY AND SET A MH AT GRADE CHANGE AND REPLACE THE LINE UP TO WALNUT STREET.

- ② 10" CONCRETE LINE THAT WHEN LAST INSPECTED SHOWED POSSIBLE STRUCTURAL DAMAGE TO THE TOP OF THE PIPE. DAMAGE MAY HAVE BEEN CAUSED DURING INSTALLATION OF OTHER UTILITIES.

- ③ 8" VITRIFIED CLAY WITH ROOT PROBLEMS.
- ④ 8" VITRIFIED CLAY WITH ROOT PROBLEMS. LINE RUNS THROUGH BACK YARDS WITH NO ALLEY.
- ⑤ 6" VITRIFIED CLAY AND SHALLOW PROBLEMS AGAIN ARE ROOTS.

- ⑥ 6" VITRIFIED CLAY WITH ROOT PROBLEMS THAT OCCUR YEARLY.
- ⑦ 8" VITRIFIED CLAY AND POSSIBLY LINED. LINE ENTERS A BRICK MH AT ELM STREET.
- ⑧ 8" VITRIFIED CLAY LINE IS SHALLOW WITH TREES NEARBY. LINE HAS ONE CONNECTION.

- ⑨ 8" AND 6" VITRIFIED CLAY WITH ROOT PROBLEMS.
- ⑩ 8" LINE WITH A COUPLE OF LOW SPOTS.
- ⑪ 8" VITRIFIED CLAY THAT HAD ROOT PROBLEMS, TREES HAVE BEEN REMOVED.
